CIRCULATING WATER PUMP FIELD REPAIR CASE NO AP-022

Chas G Allen received an emergency request to repair an I-R Model 60APMA-1, rated 140,000GPM @ 26'TDH. The unit provides cooling water to a 650Mw base loaded coal fired station. This is a non-pullout style design in which the outer column was constructed in carbon steel and had deteriorated to near catastrophic failure in the saltwater. Several years prior the customer installed a carbon steel column from the OEM as the unit was schedule to be replaced within a few years of the last repair. Scheduling changes move the replacement project out another eight years from the original plan.

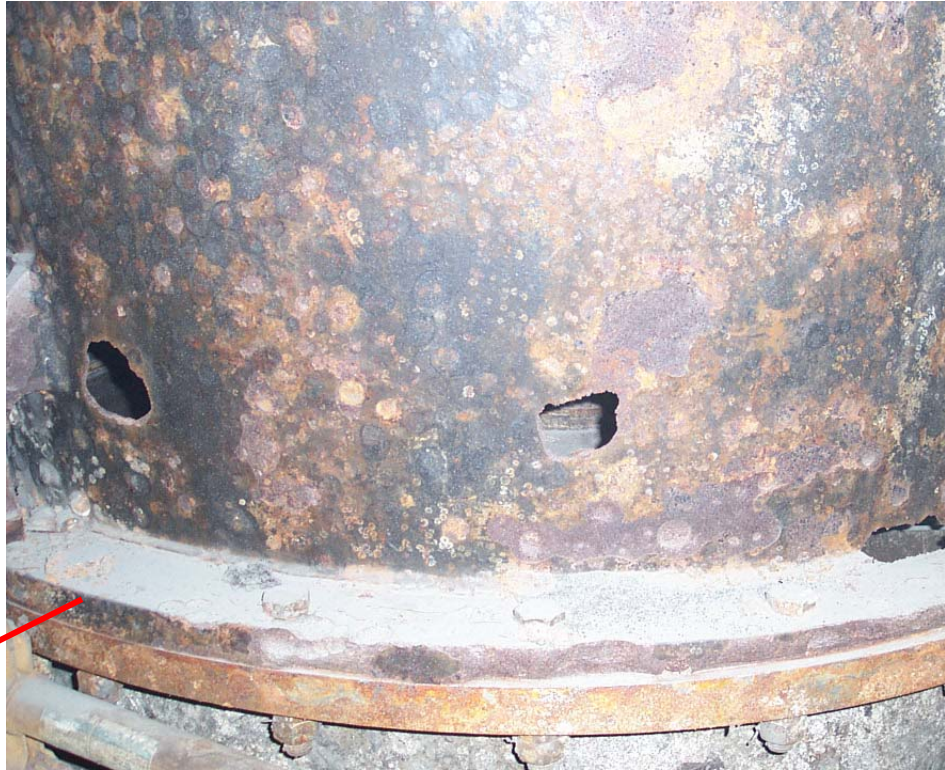
Typical of the corrosion/erosion damage to the upper column at the flange to the casing, note the major damage is closest to the 316SS casing.

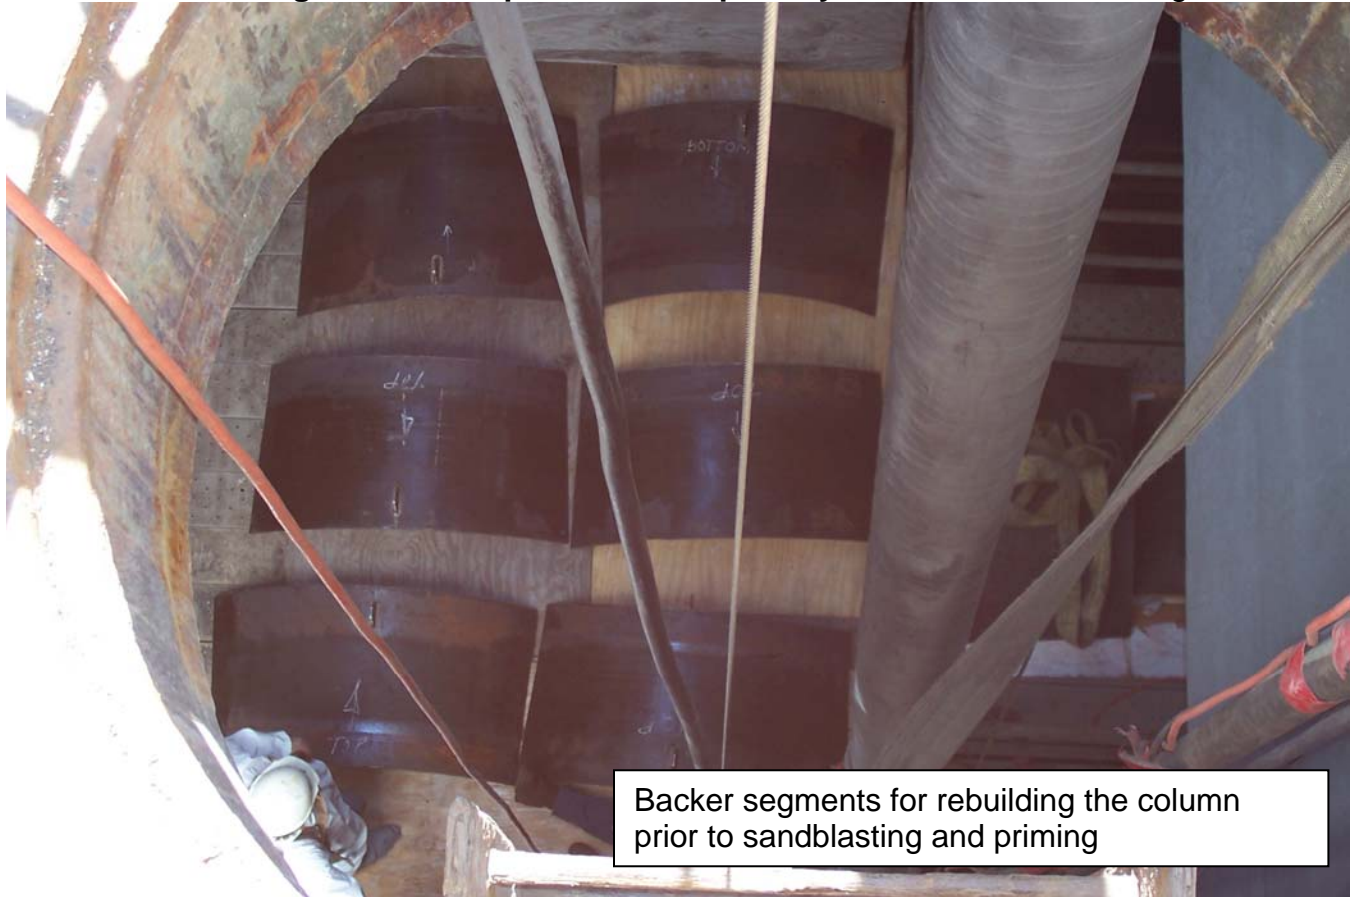
Backer segments for rebuilding the column prior to sandblasting and priming

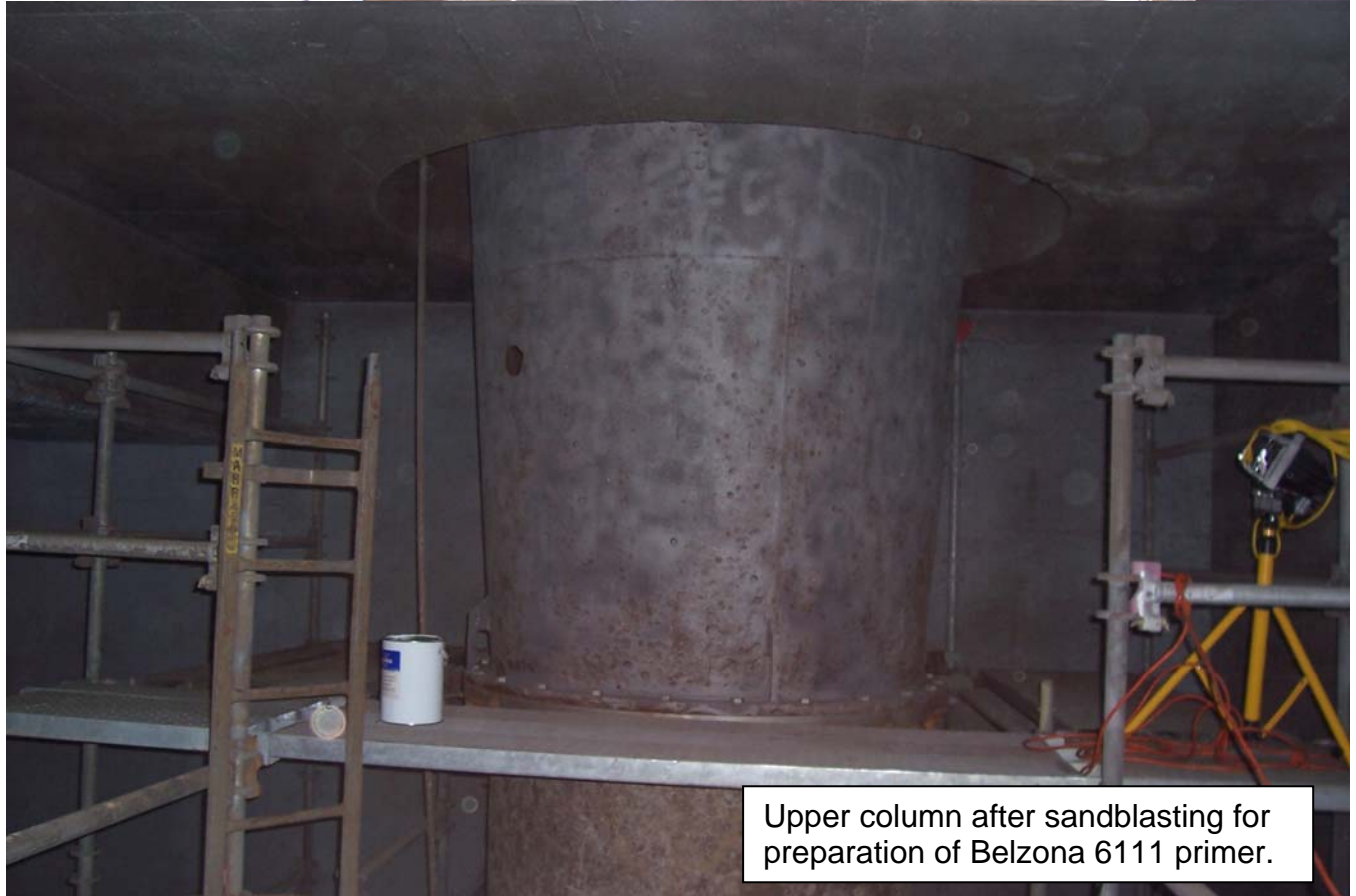
Upper column after sandblasting for preparation of Belzona 6111 primer.

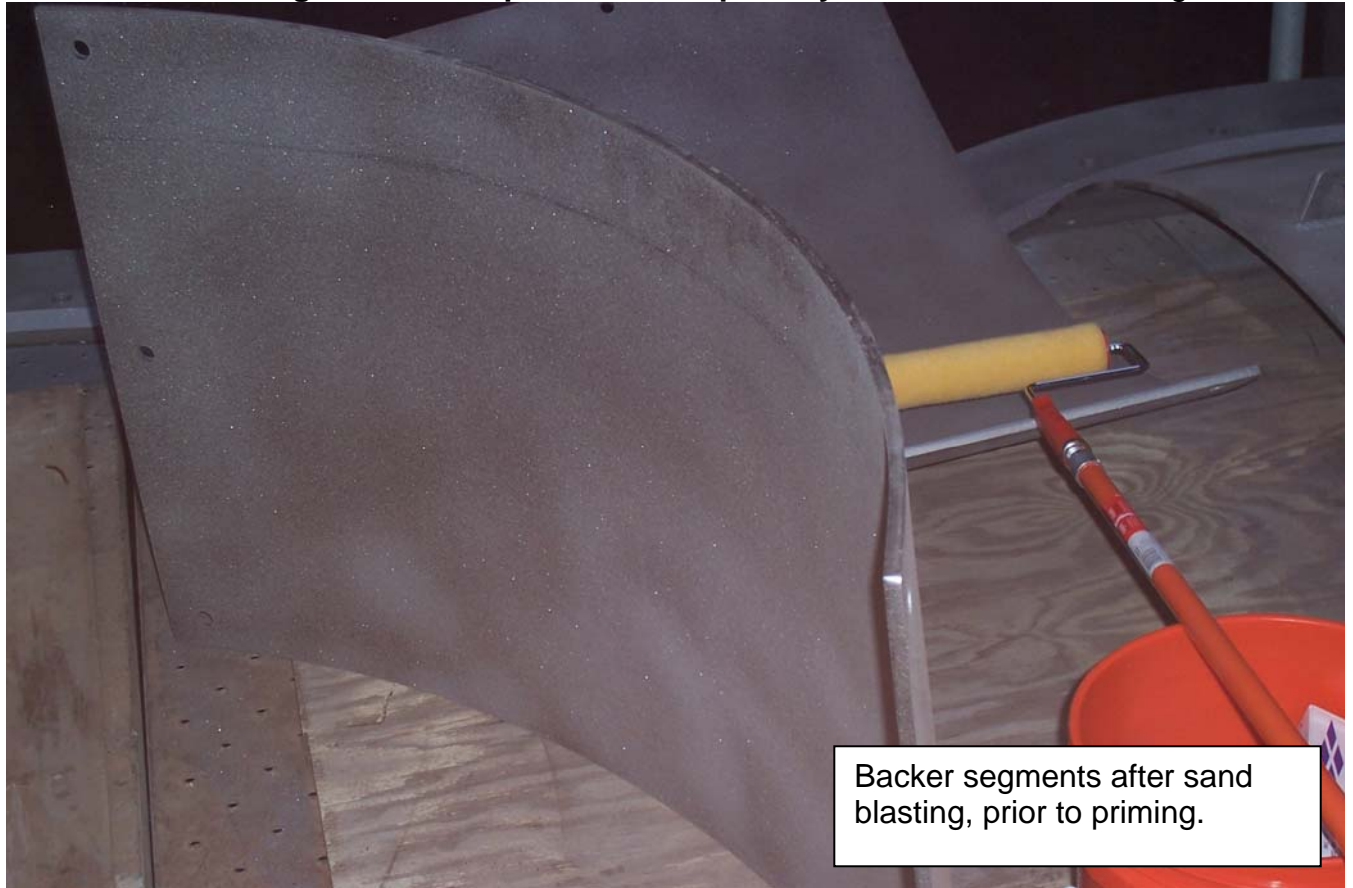
Backer segments after sand blasting, prior to priming.

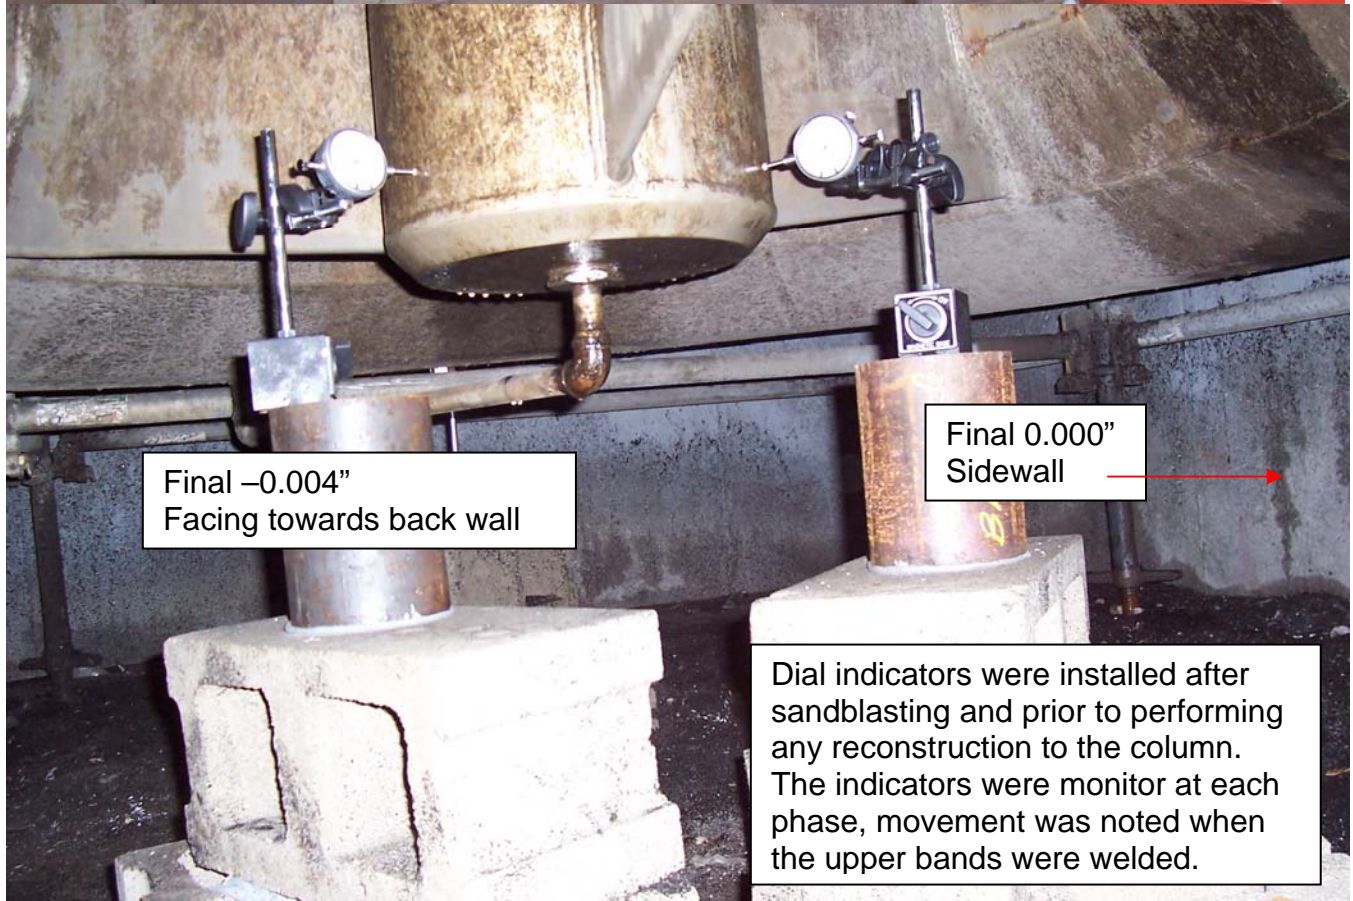
Final -0.004"
Facing towards back wall

Final 0.000"
Sidewall →

Dial indicators were installed after sandblasting and prior to performing any reconstruction to the column. The indicators were monitor at each phase, movement was noted when the upper bands were welded.

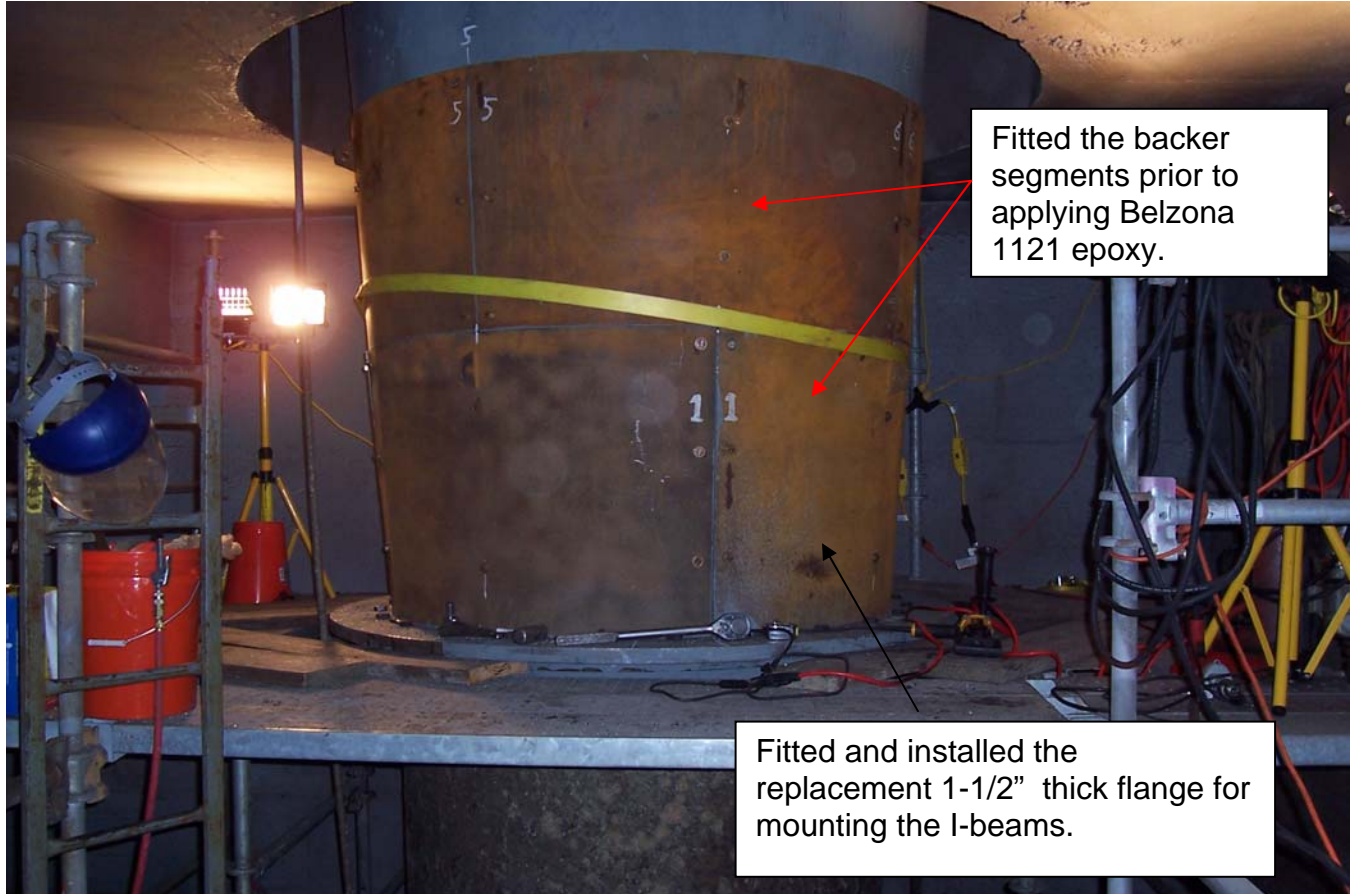
Fitted the backer segments prior to applying Belzona 1121 epoxy.

Fitted and installed the replacement 1-1/2" thick flange for mounting the I-beams.

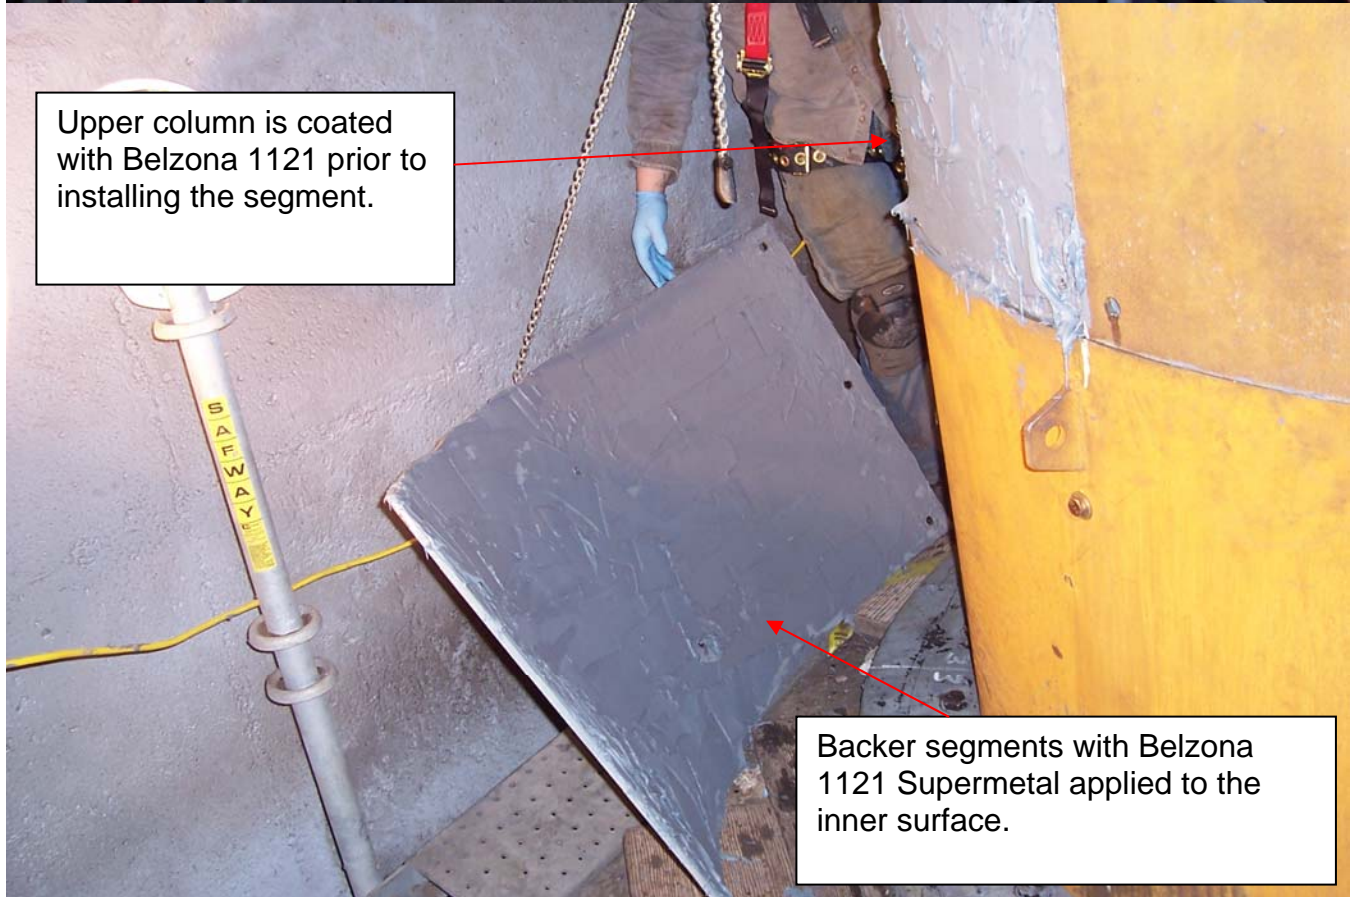
Upper column is coated with Belzona 1121 prior to installing the segment.

Backer segments with Belzona 1121 Supermetal applied to the inner surface.

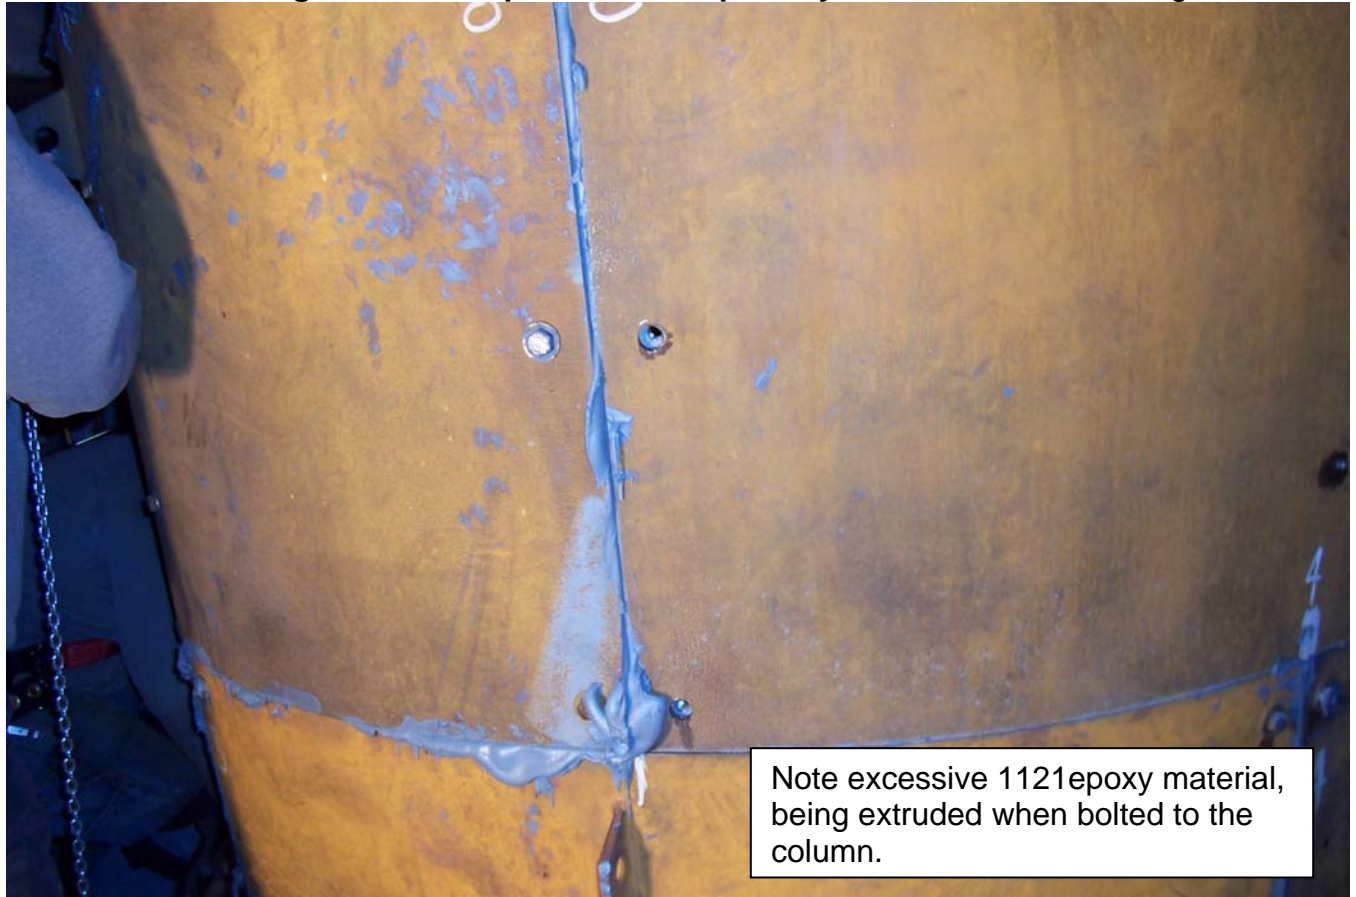
Note excessive 1121 epoxy material, being extruded when bolted to the column.

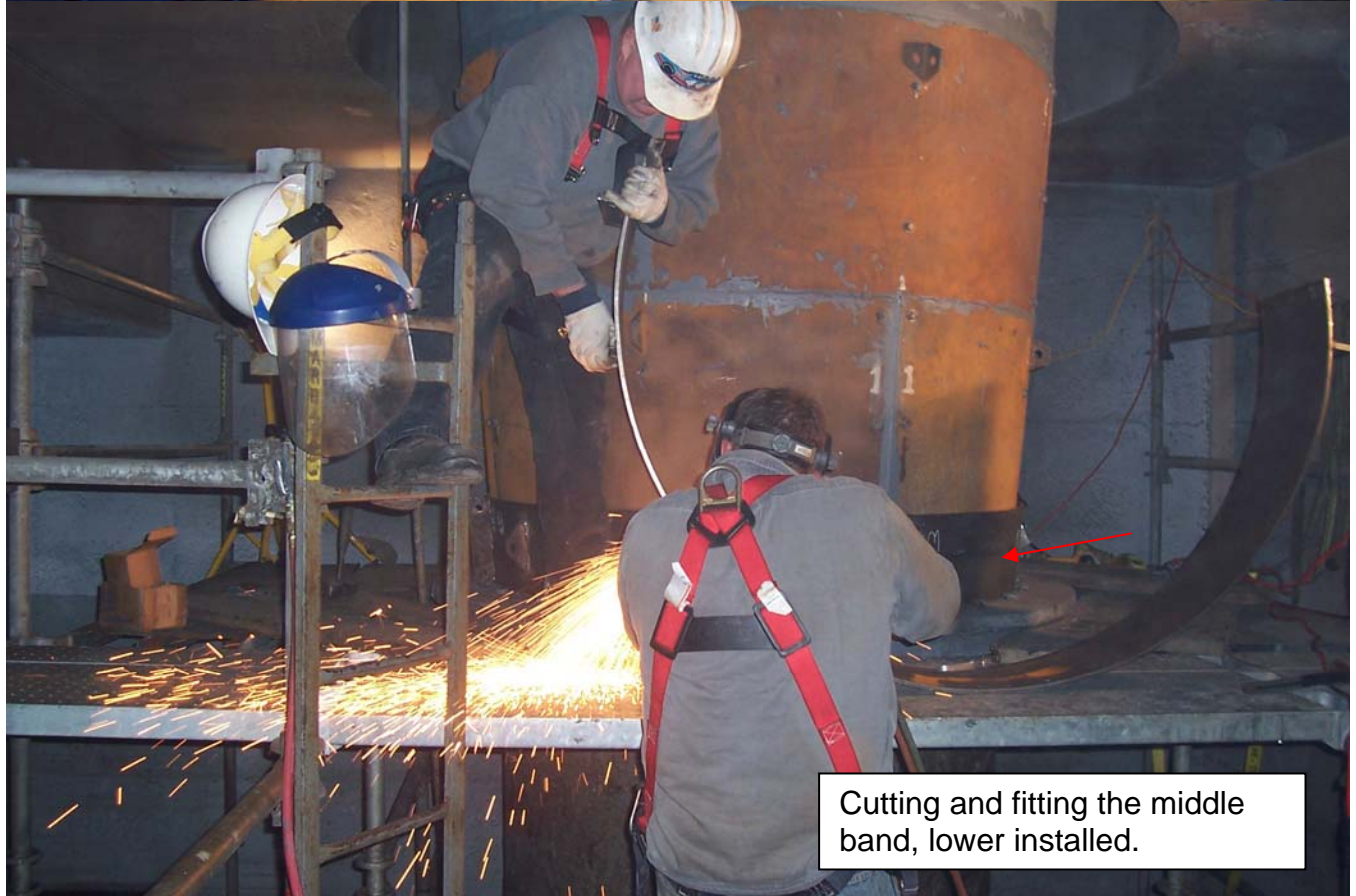
Cutting and fitting the middle band, lower installed.

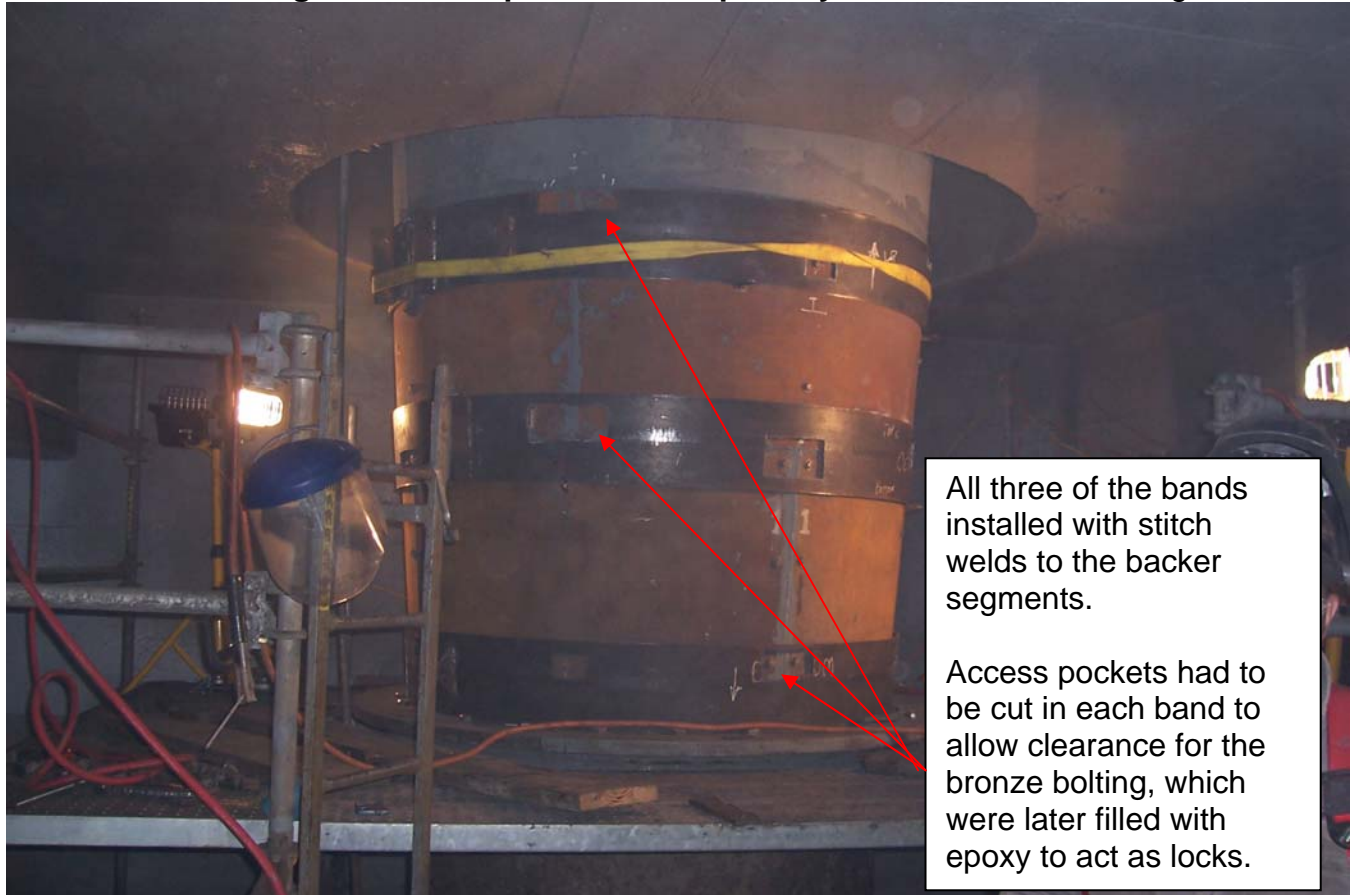
All three of the bands installed with stitch welds to the backer segments.

Access pockets had to be cut in each band to allow clearance for the bronze bolting, which were later filled with epoxy to act as locks.

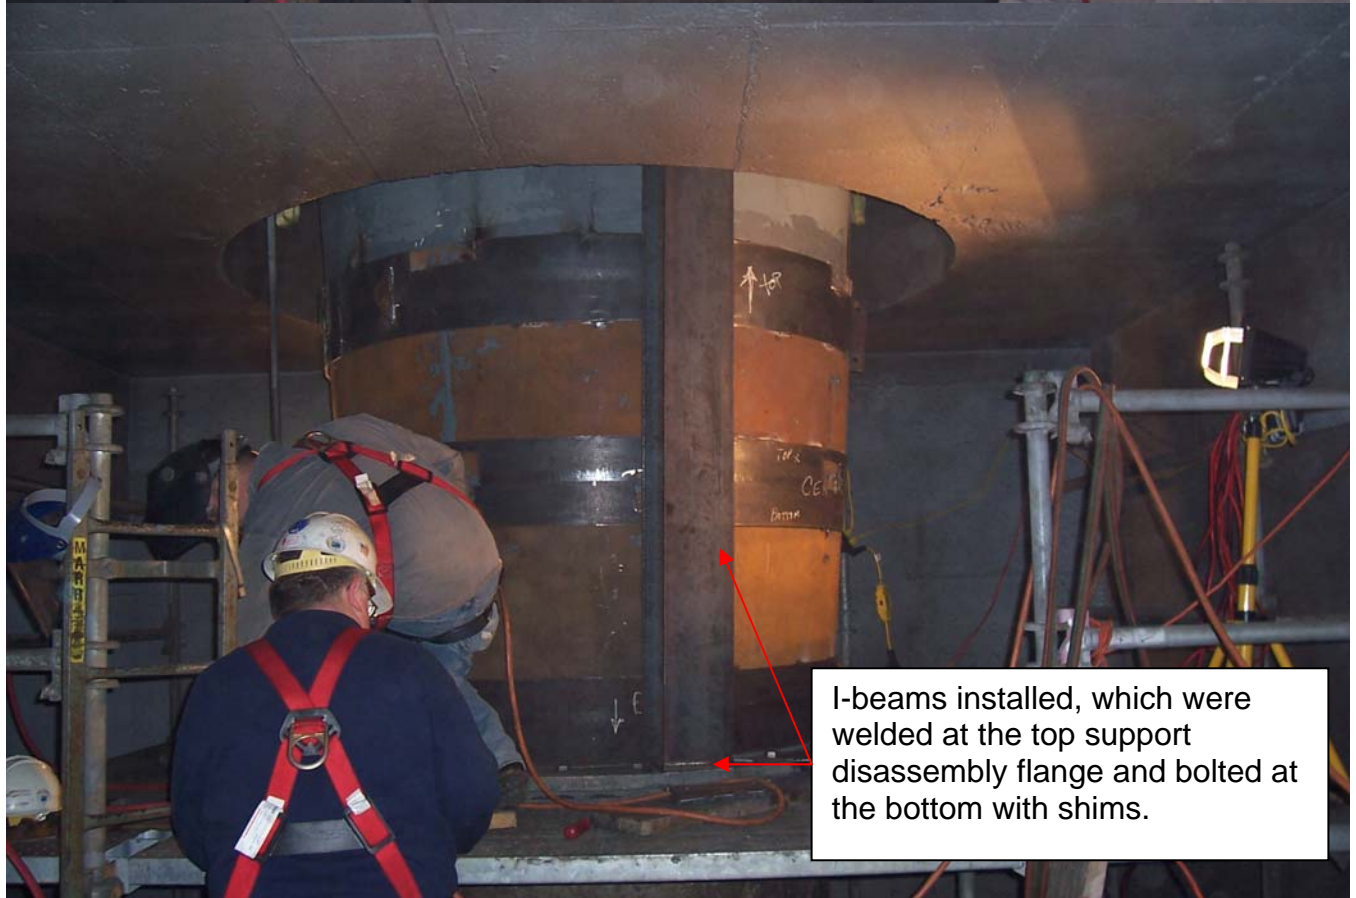
I-beams installed, which were welded at the top support disassembly flange and bolted at the bottom with shims.

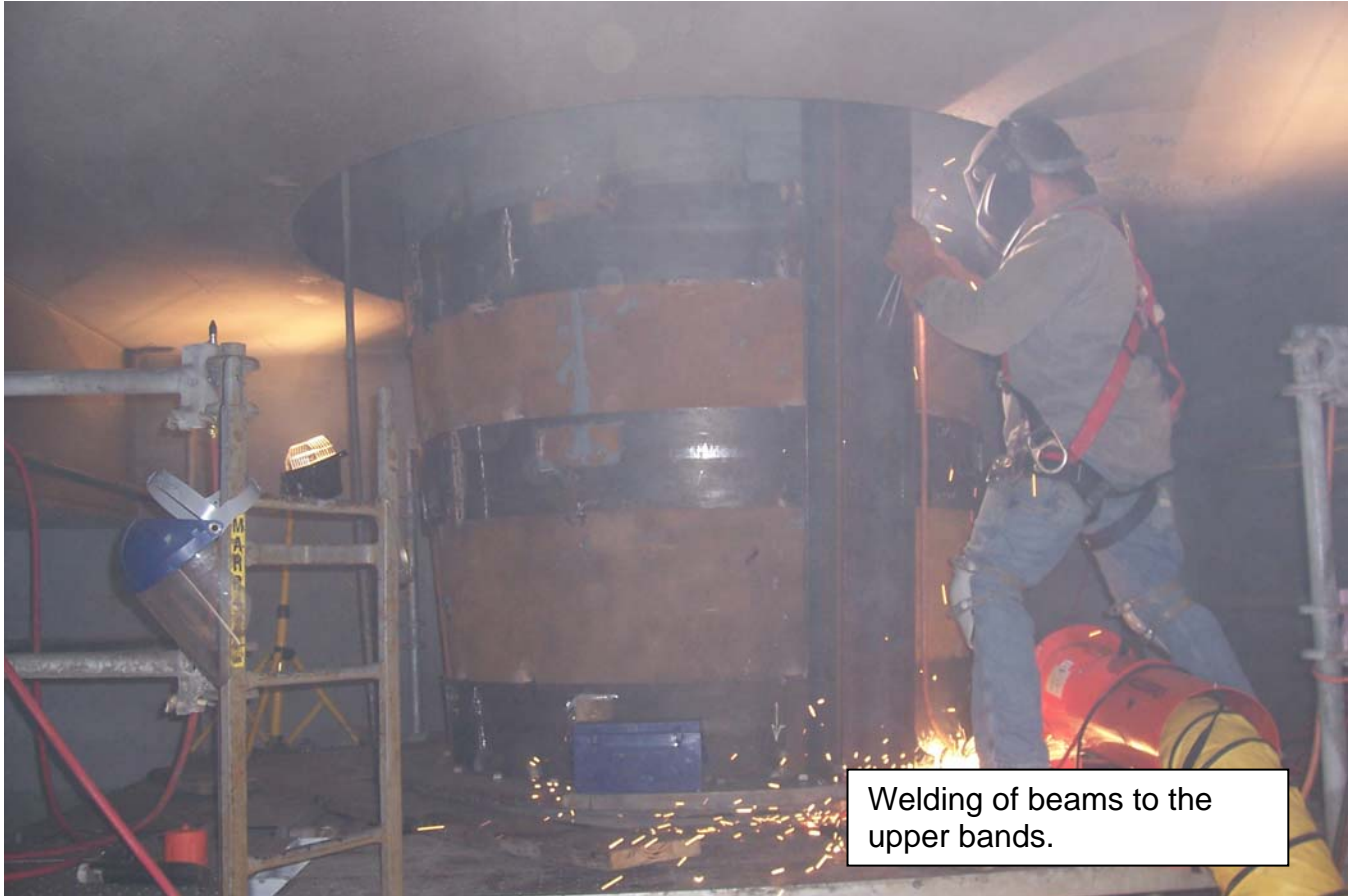
Welding of beams to the upper bands.

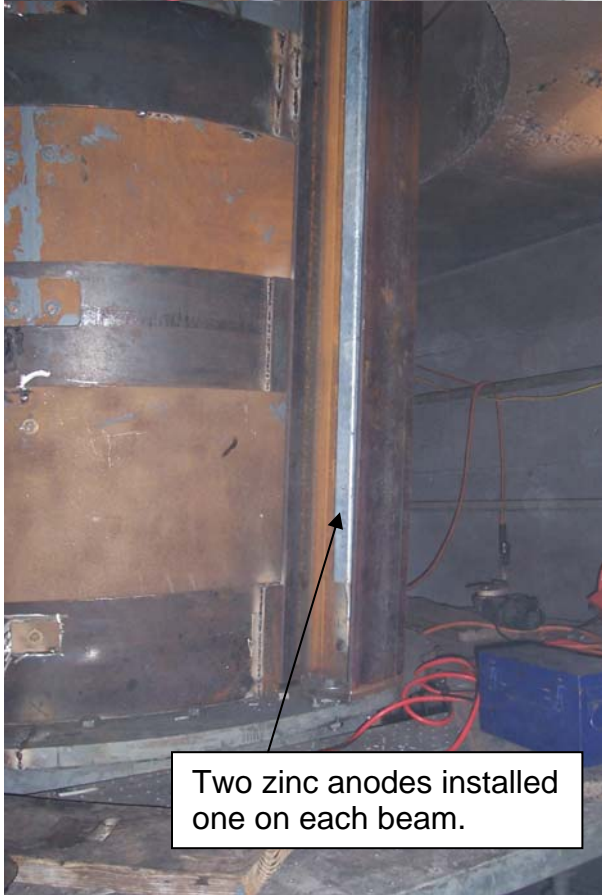
Two zinc anodes installed one on each beam.

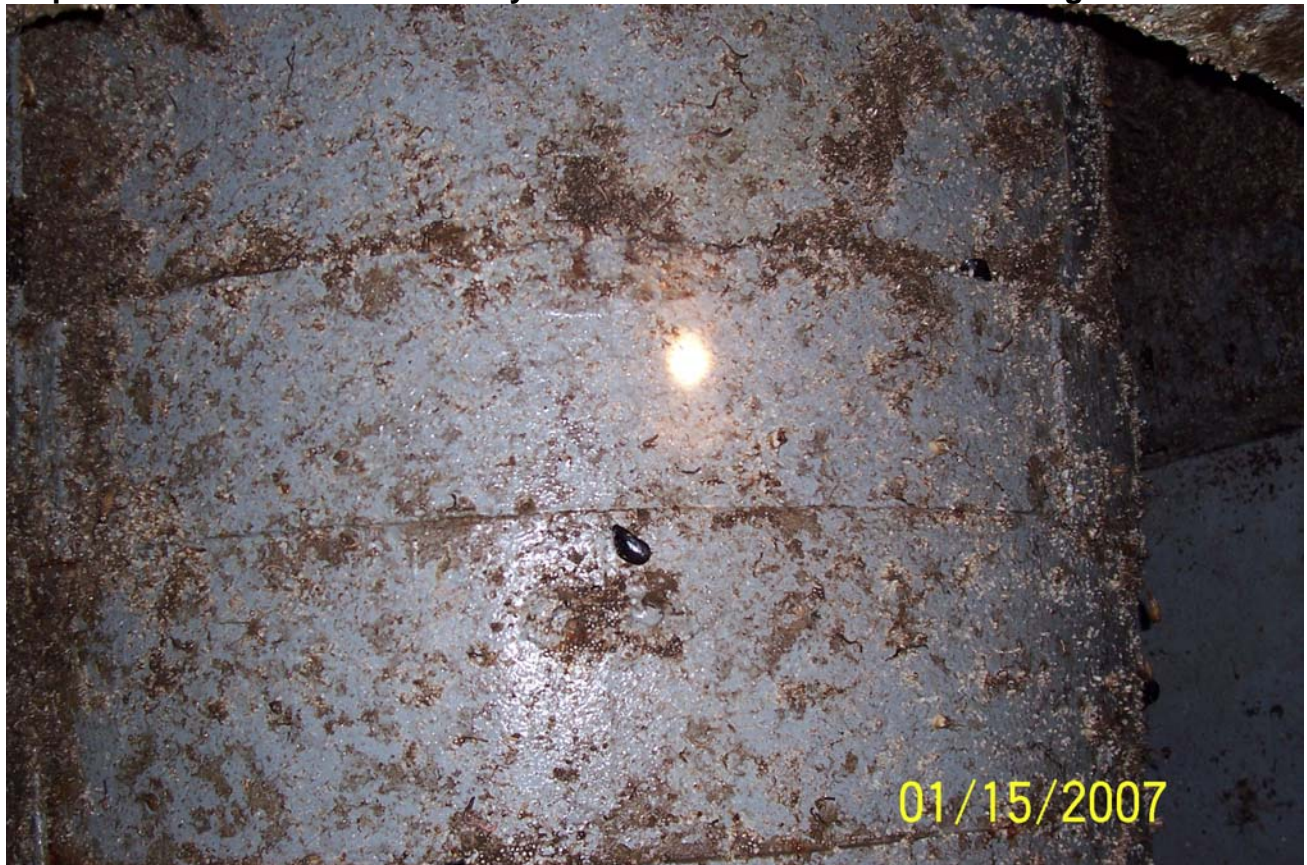
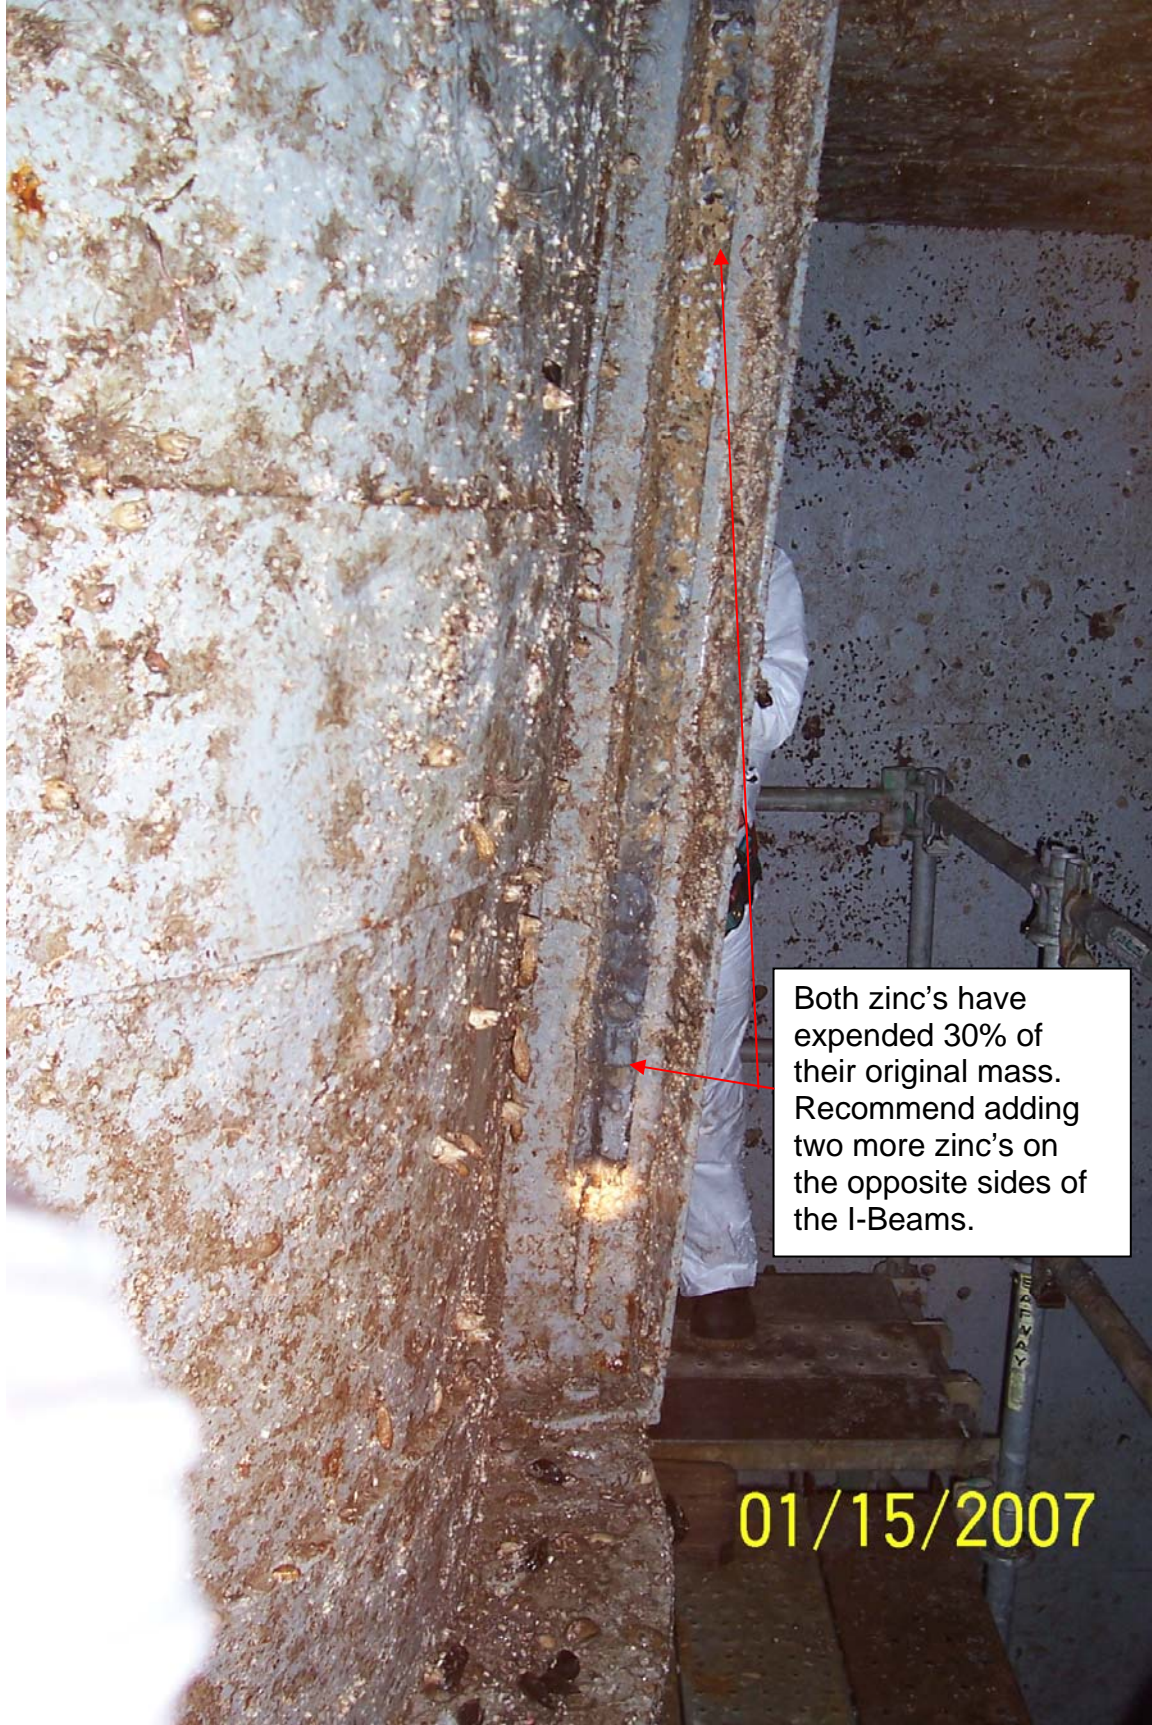
Both zinc's have expended 30% of their original mass. Recommend adding two more zinc's on the opposite sides of the I-Beams.

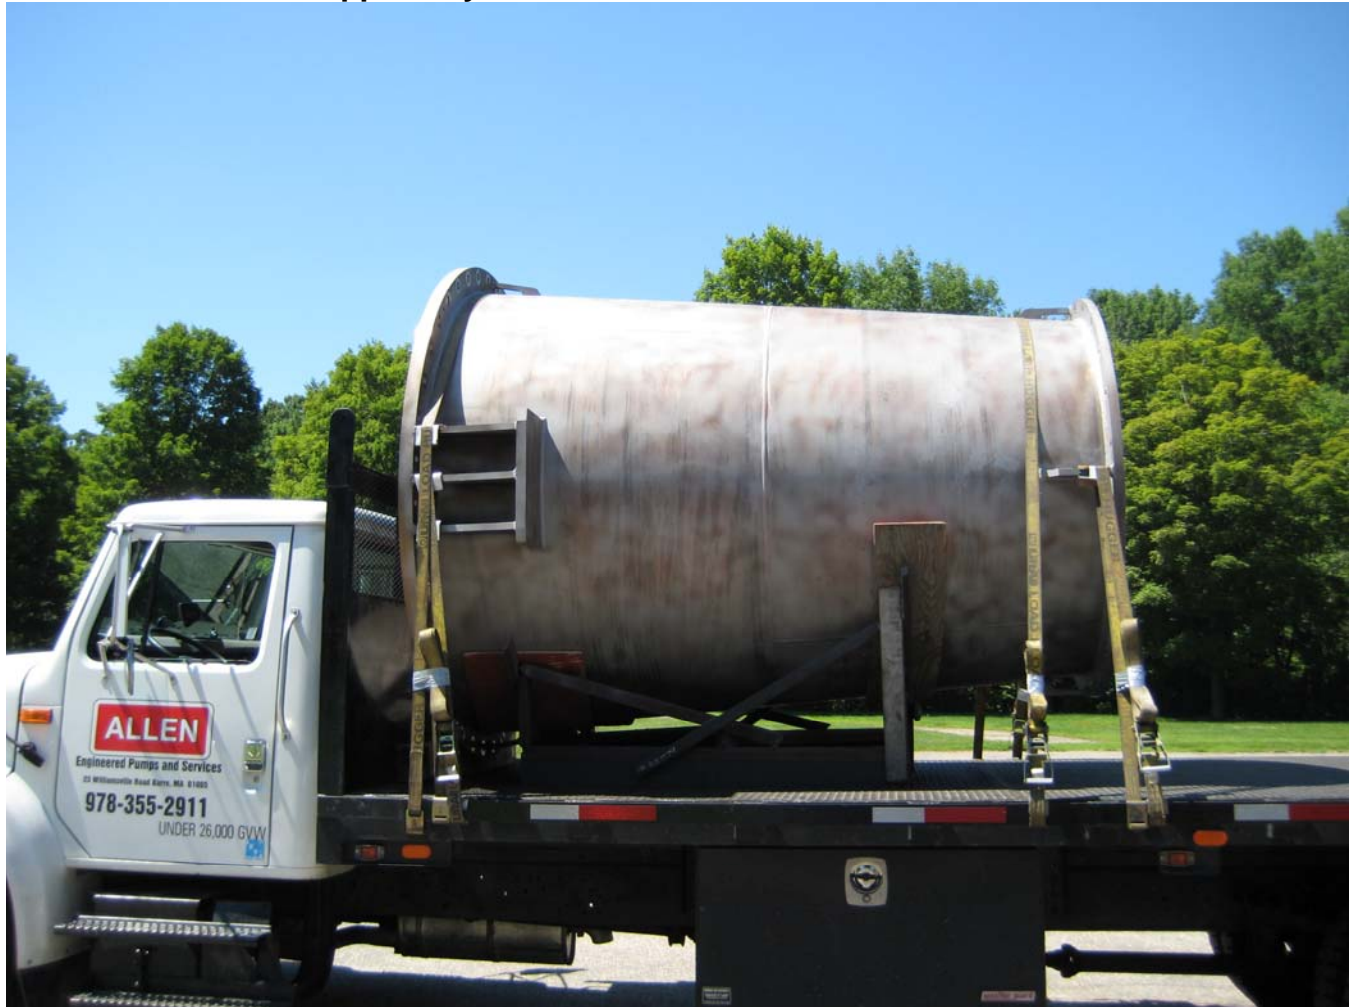
New Outer Column supplied by CGA in 316SS
