CIRCULATING WATER PUMP FIELD REPAIR CASE NO AP-022

Chas G Allen received an emergency request to repair an I-R Model 60APMA-1, rated 140,000GPM @ 26'TDH. The unit provides cooling water to a 650Mw base loaded coal fired station. This is a non-pullout style design in which the outer column was constructed in carbon steel and had deteriorated to near catastrophic failure in the saltwater. Several years prior the customer installed a carbon steel column from the OEM as the unit was schedule to be replaced within a few years of the last repair. Scheduling changes move the replacement project out another eight years from the original plan.

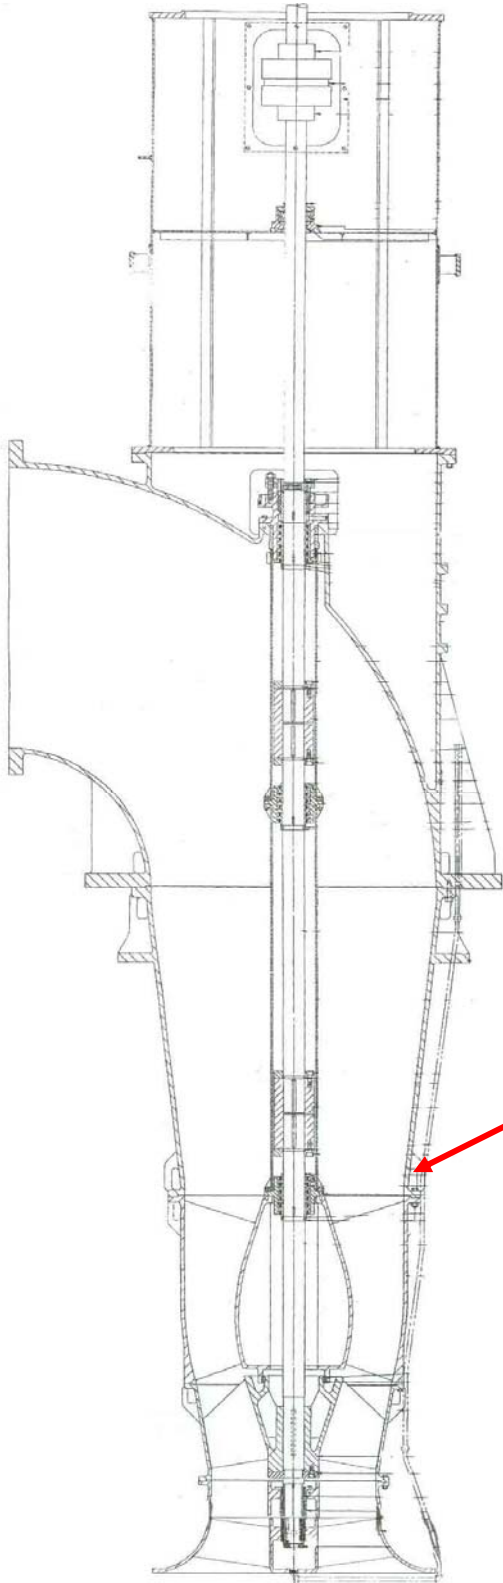
The station was in the 2nd week of a schedule 4 week outage when it was discovered during routine cleaning of the intake pit that the outer column had numerous holes 6" in diameter with serious erosion at the lower flange to the casing.

Typical of the corrosion/erosion damage to the upper column at the flange to the casing, note the major damage is closest to the 316SS casing.

CGA evaluated the damage and devise a corrective action plan until a new column could be fabricated. Fabrication of the new column had minimum of 6-8 week lead-time in 316SS. Due to the severe erosion and unknown actual thickness of the column, removing the unit would probably have due more damage to the other stainless components (shafting, inner columns, casing) and in-place repair was the only option.

The column was dimensional recorded and new carbon column was fabricated in sections. A new lower flange was also constructed in sections. Prior to installation these components were prepared by blasting to near white metal and utilizing special primers.

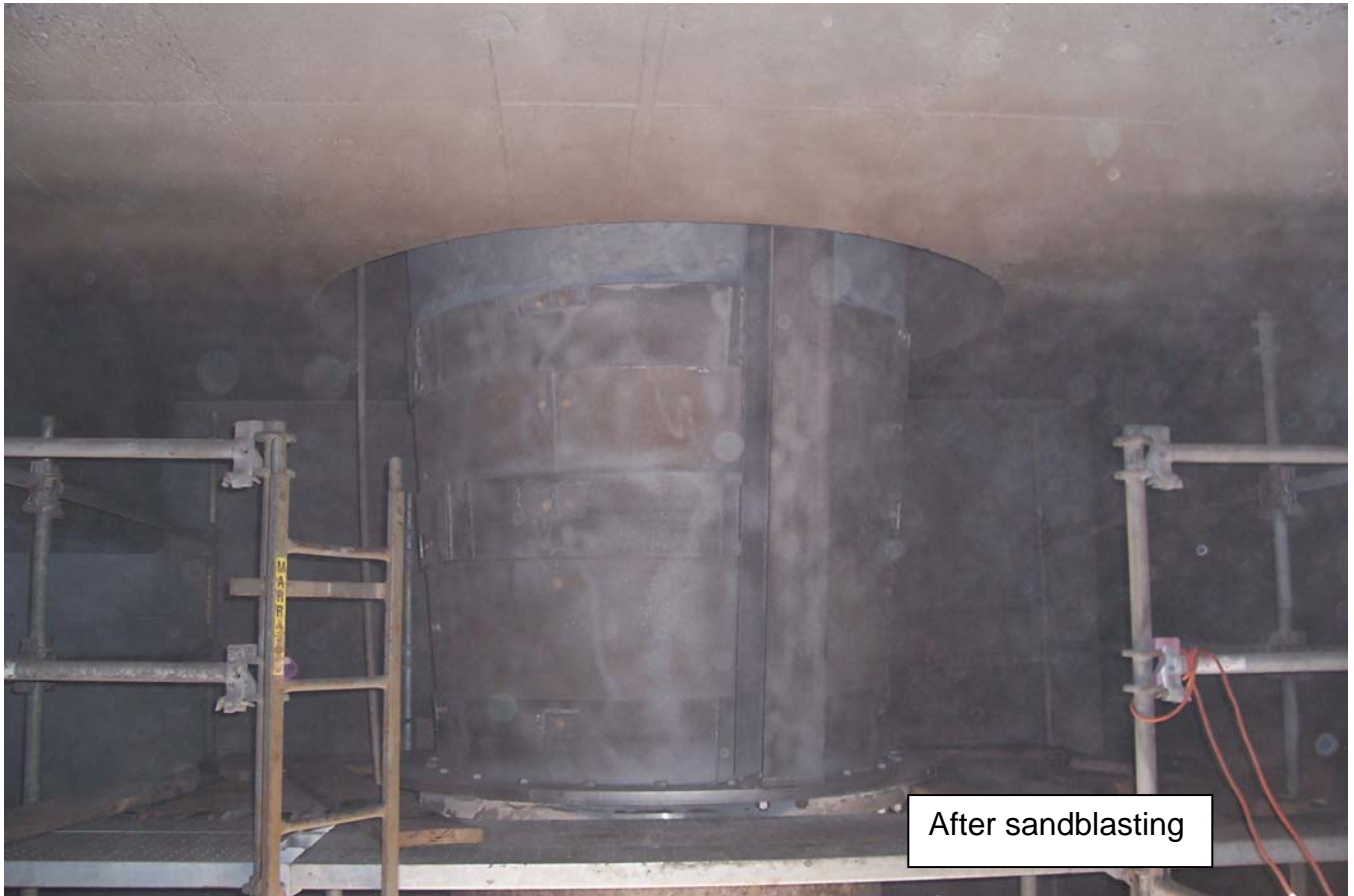
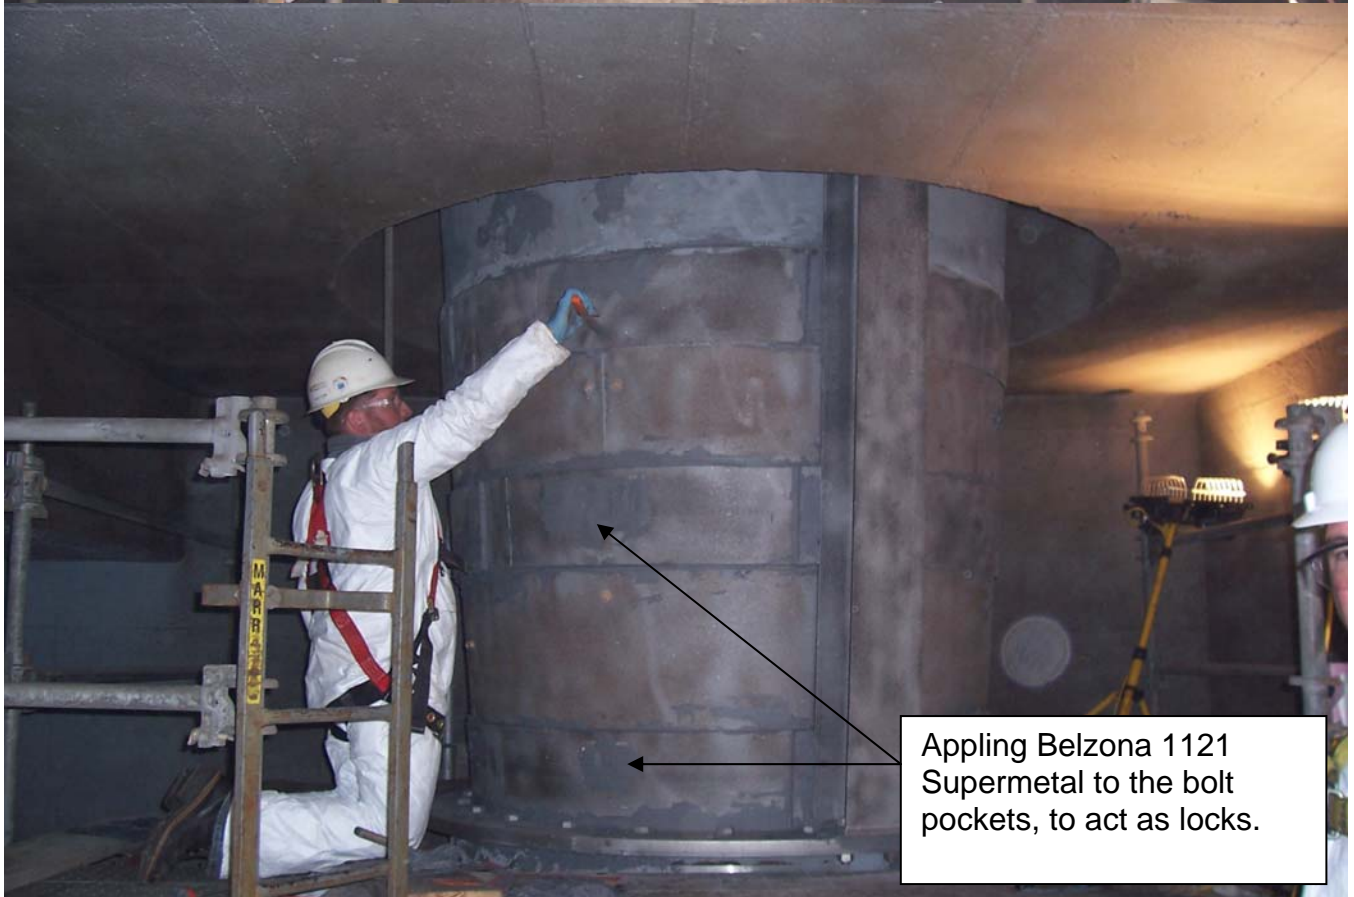
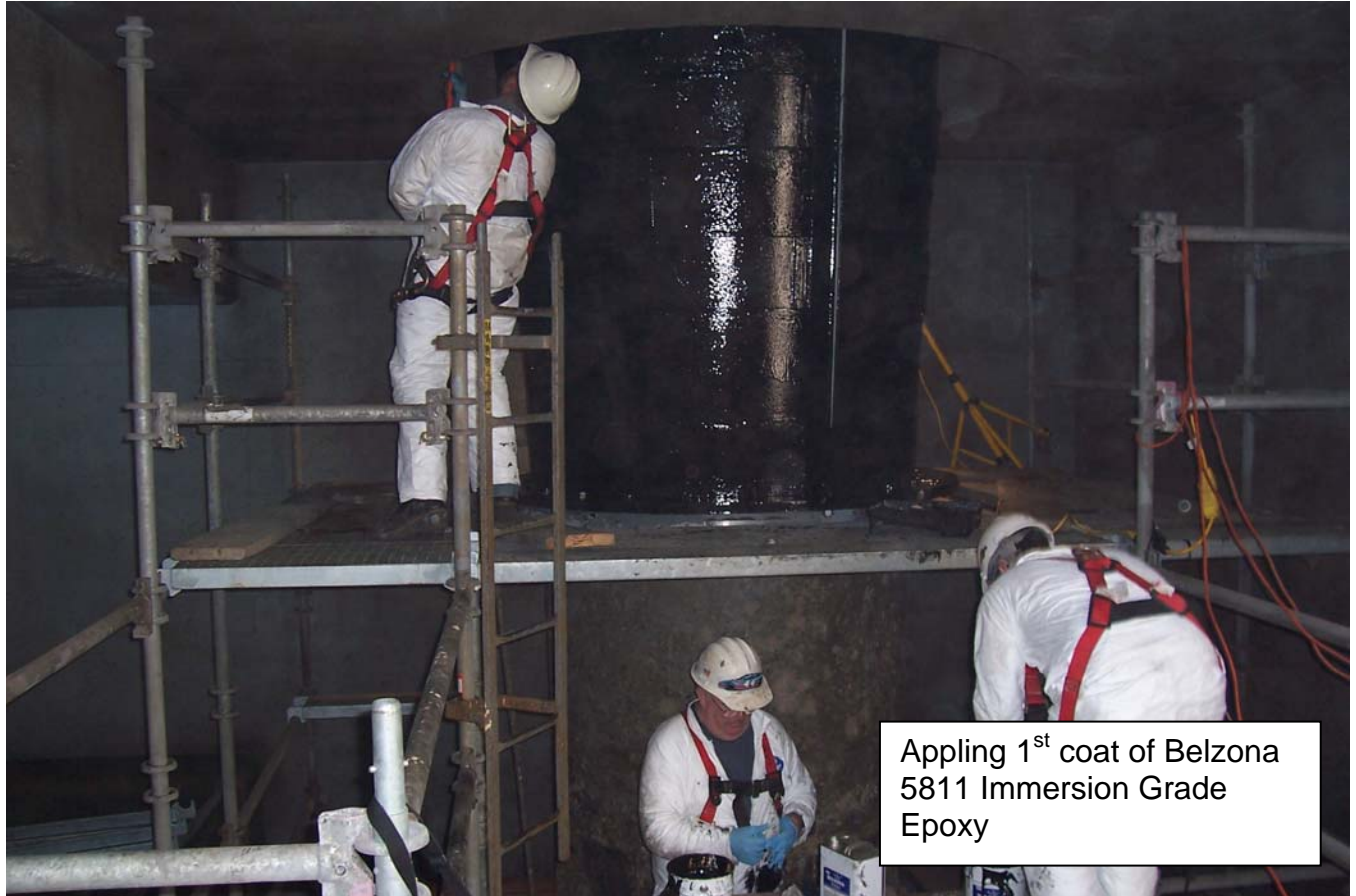
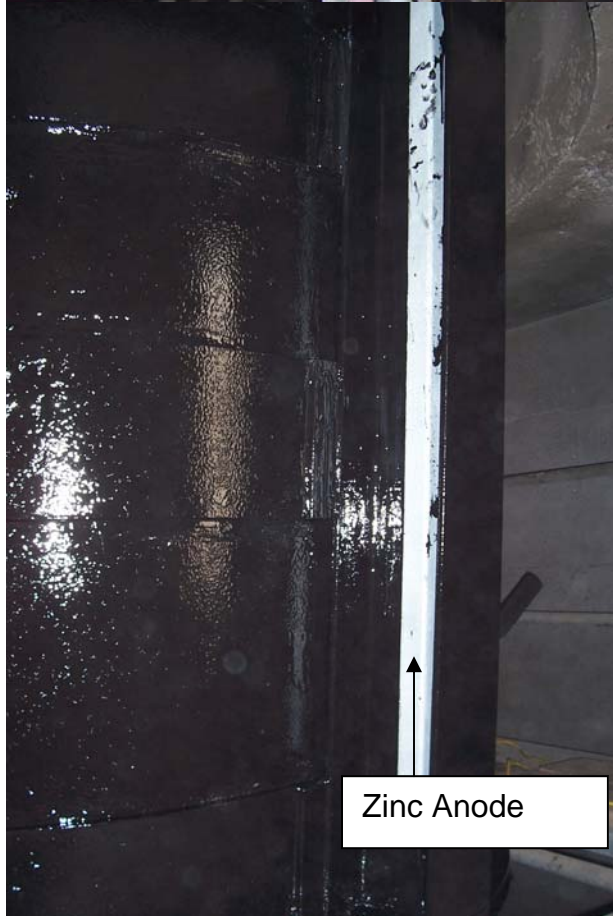
Inspection of repair almost one year later still in good condition. Subsequent yearly inspections have not revealed any deterioration over than the marine growth shown

Both zinc's have expended 30% of their original mass. Recommend adding two more zinc's on the opposite sides of the I-Beams.
